SR 108 MP 5.54 Unnamed Tributary to Skookum Creek (WDFW ID 990385): Preliminary Hydraulic Design Report

Julie Heilman PE, State Hydraulic Engineer WSDOT Headquarters Hydraulics Office

Beth Rood PE, Project Manager HDR Engineering, Inc.

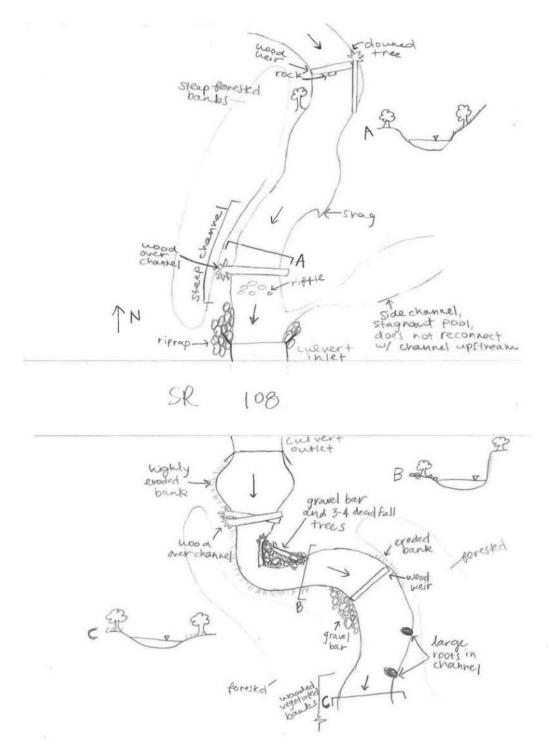
Figure 6: Plan view and cross sections of upstream and downstream reaches of the crossing (not to scale)

The following paragraphs and Figure 7 through Figure 36 describe field observations of the UNT from upstream to the downstream confluence with Skookum Creek. Figure 6 shows a plan view of the Tributary upstream and downstream of the crossing, sketched from observations made during the site visit. It highlights features in the Tributary such as large woody material (LWM), planform shape, cross-sectional shape, and confluences.

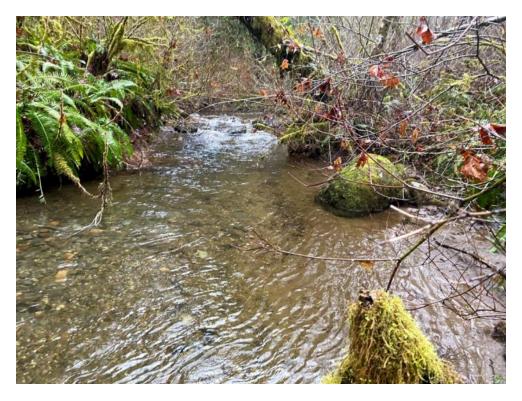
Figure 7: Looking upstream from the wood weir

The upstream reach of the UNT has consistently vegetated banks with wooded floodplains. LWM is present throughout the upper reach and some riffles were also observed. The reach substrate is consistently gravel and small cobbles. Beginning approximately 300 feet upstream of the crossing, the UNT passes through riffles before taking a rough 75-degree right turn over a fallen wood weir spanning the entire channel, creating a 2-foot hydraulic drop (see Figure 8).

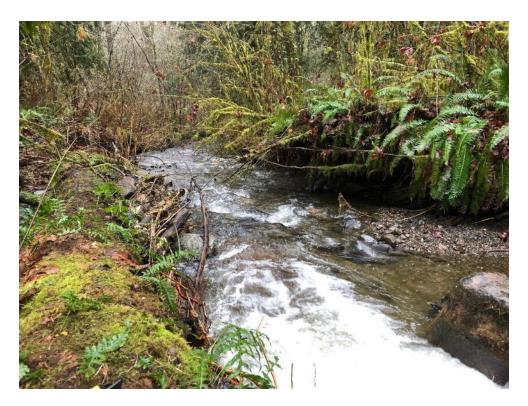
Figure 9: Downstream of the rock and wood weir

Directly downstream of the drop, the right banks are slightly undercut and there is woody material on the left banks as the channel takes a slight right turn. Banks in this reach are 2 to 3 feet tall.

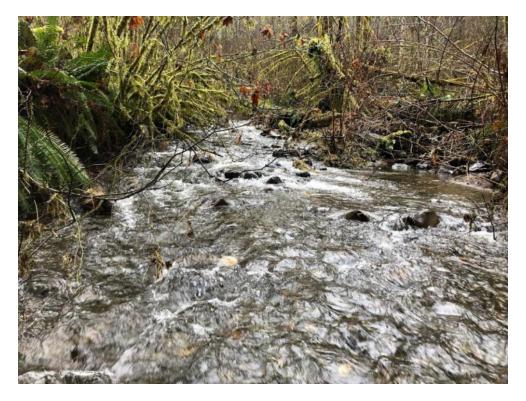
Figure 10: Straight run looking upstream

Downstream of the bend, the channel remains fairly straight in a run, with the thalweg generally keeping to the left side of the channel. Three bankfull widths were taken spaced 30 feet apart at this location, beginning 50 feet downstream of the wood weir. The average bankfull width was 20.8 feet. Within the bankfull width area the largest material of 21.3 inches (in) (542 millimeters [mm]) was found (see Figure 41).

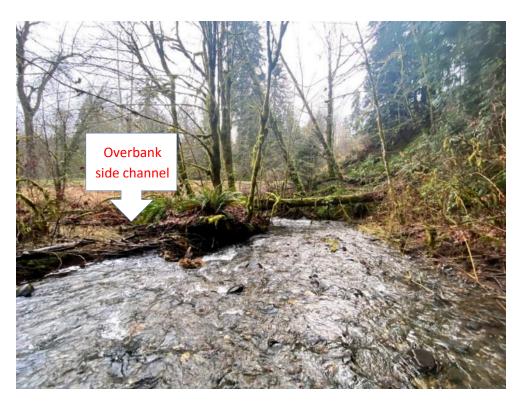
Figure 12: Looking downstream at left bank overbank side channel beginning

About 30 feet downstream of the bankfull width area, the channel takes a slight bend to the right. A small overbank side channel begins at this location, with some overbank flow at higher flows entering the side channel that reenters just upstream of the culvert.

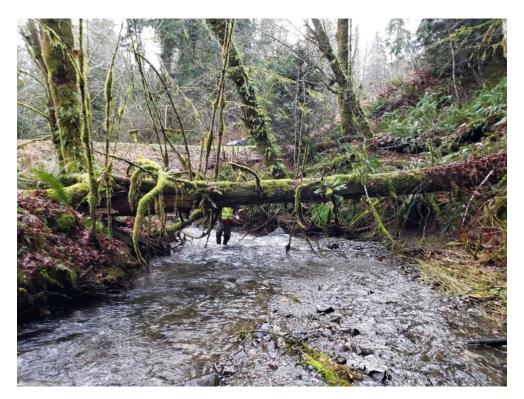
Figure 14: Upstream of the fallen tree, looking downstream

Continuing down the mainstem of the Tributary, the left banks are about 2 feet high and the right banks are 3 feet high with a small gravel bar in the middle of the channel. A downed tree spans the channel banks 3 feet above the stream that marks a differing channel slope. Upstream the channel is fairly shallow, and downstream the channel is much steeper traveling over a short cascade leading into the

culvert. The cascade contains angular material that either was placed or fell into the channel from the right bank.

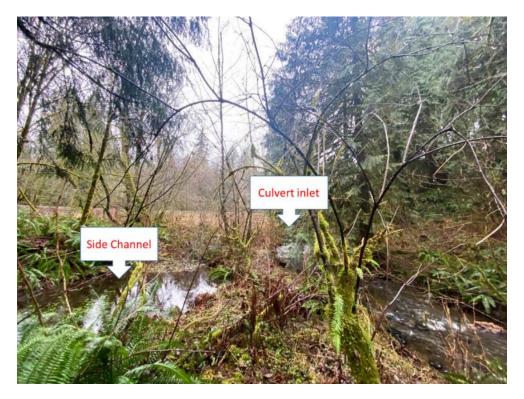
Figure 16: Looking downstream from atop the left bank

A side channel begins approximately 150 feet upstream of its confluence with the Unnamed Tributary just upstream of the culvert inlet. It has no upstream connection to the Tributary. It meanders 30 to 50 feet to the left of the Tributary until stagnating at a large pool directly upstream of the confluence.

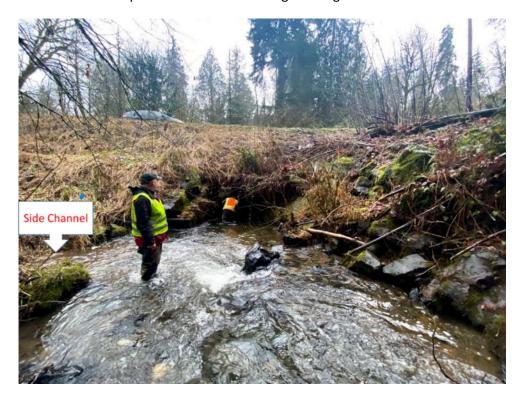
Figure 18: Looking downstream at the culvert inlet

The channel is steep with angular material within the channel as it enters the culvert and heavy riprap on the 7-foot-high right banks. The side channel outfalls to the left of the culvert inlet. The 6-foot-span concrete box culvert has an exposed bottom with 45-degree wingwalls.

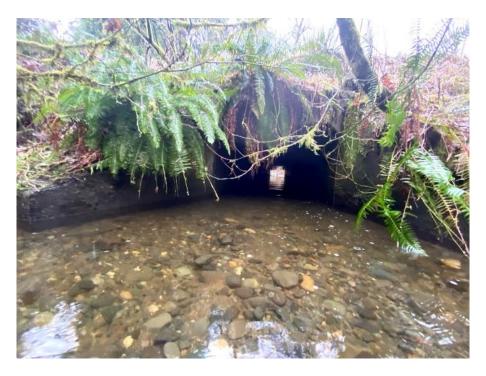
Figure 20: Looking upstream at the culvert outlet

The culvert outlet has concrete wingwalls with 45-degree angles. The bottom is not exposed and natural material is present within the downstream end of the culvert.

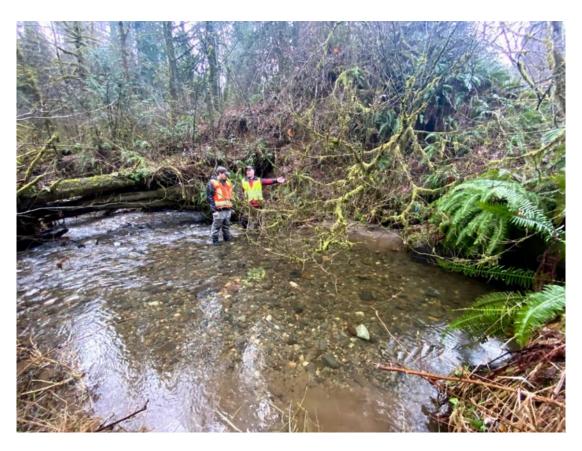
Figure 22: View from the left bank at the culvert outlet looking downstream

At the culvert outlet there is a larger pool. Downstream of the pool there are several deadfall trees from an eroded right bank. There is a riffle at the downstream end of the culvert outlet pool as flow transitions under the downed trees and flow is directed toward the right bank.

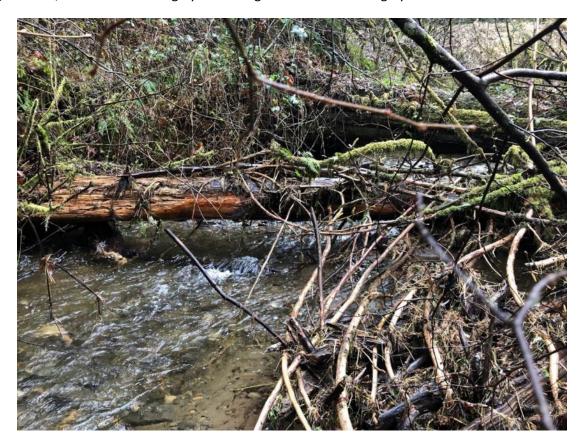
Figure 24: Looking upstream from the debris-filled left bank

Continuing downstream there is woody material within the stream that has directed flow into the right bank and caused erosion along the right bank. The wood has helped accumulate smaller wood, sediment, gravel, and sandy substrate. This obstruction has confined the channel to the right at a 90-degree bend, and has created highly eroded right banks that sit roughly 5 feet tall.

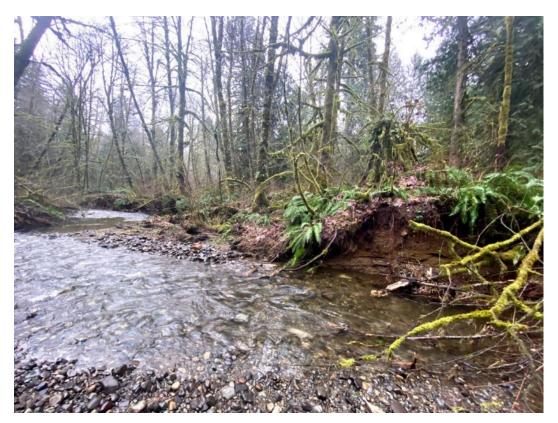
Figure 27: Looking downstream at right 90-degree turn

Immediately downstream of the blockage, the channel straightens for about 15 feet and takes a 90-degree bend to the right. As the right bank declines from 5 feet high to approximately 1 to 2 feet with a right bank point bar, the left banks increase from a gravel bar to about 3 to 4 feet high with many roots extending into the channel. Throughout the channel the banks are a sandy material.

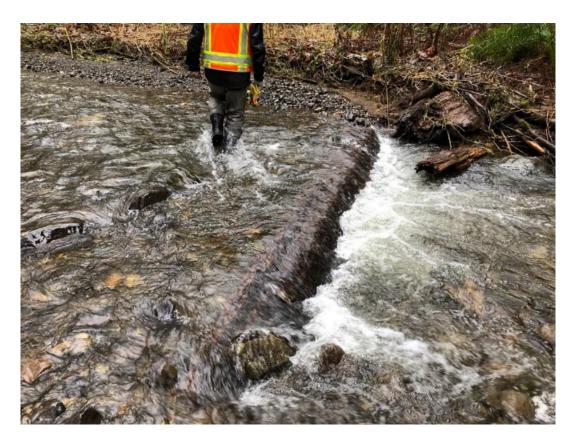
Figure 29: From the right bank, looking at the wood weir

Downstream of the bend the channel meanders slightly to the left. From this point on, the banks remain vegetated and are not as eroded compared to the immediate upstream reach. A wood weir spanning the channel creates a 1-foot hydraulic drop as the channel bends to the right. Downstream of the weir woody material is present on both the left and right sides of the channel.

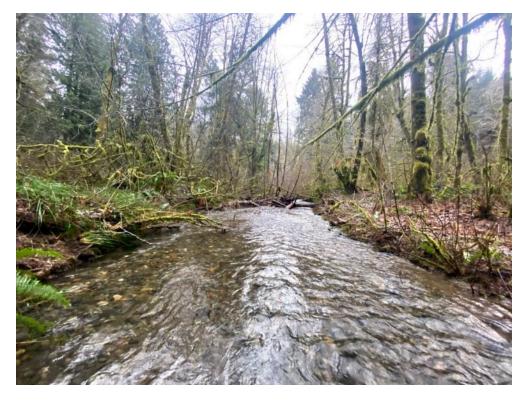
Figure 32: Looking downstream at the log jam

The Tributary continues along a straight path for approximately 50 to 60 feet until reaching a log jam that spans almost the whole channel. It consists of one or two downed trees along with smaller mobile woody material that has accumulated on the jam. It forces the Tributary to cross near the right bank, creating a gravel bar in the middle of the channel immediately downstream of the jam.

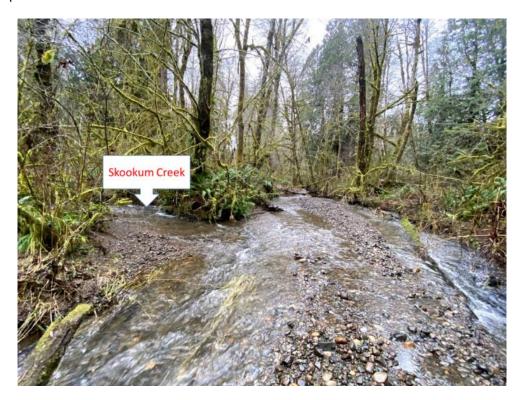
Figure 35: Looking upstream at the confluence of Skookum Creek and the tributary just before the log jam

The Tributary continues roughly 50 feet to the confluence with Skookum Creek, which joins the mainstem from the left bank. The Tributary is almost double the bankfull width of Skookum Creek.

Approximately 20 feet downstream of the confluence another log jam that has accumulated woody material spans the entire channel.

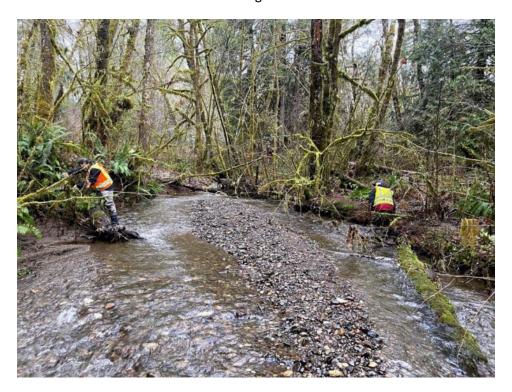
Figure 37: Bankfull width measurement being taken, looking upstream

Six bankfull widths were taken beginning 20 feet upstream of the confluence and spaced 20 feet apart moving upstream (both downstream and upstream of the initial log jam). The average bankfull width for this downstream reach was 22.2 feet. Bankfull measurements are summarized in Section 2.8.2. Figure 37 below shows a bankfull width measurement being taken.

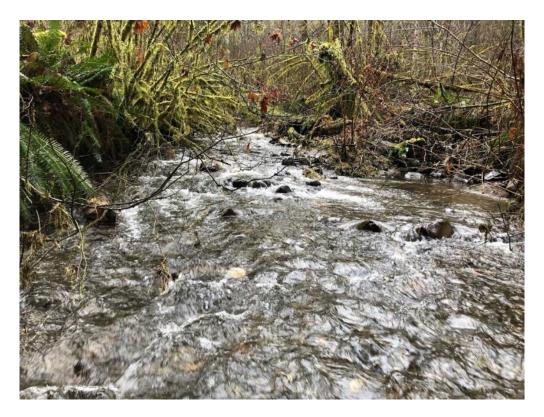
Figure 38: Photo of reference reach, looking upstream; the reference reach is at the bottom of the photo

A section of stream approximately 200 feet upstream of the culvert (see Figure 38 and Figure 39) was identified as the reference reach because it is most representative of a naturally occurring channel, with the least amount of anthropogenic influences. This reach has an approximate average channel gradient of 2.1 percent. Results of a pebble count conducted within the reference reach are summarized in Section 2.8.3.

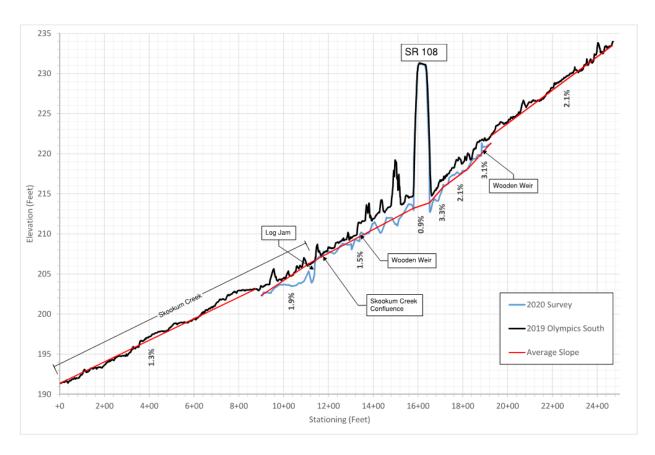
Figure 43: Watershed-scale longitudinal profile

At the farthest upstream point of the survey the channel meanders slightly, but is defined by vegetated floodplains within the Kamilche Valley. Outside of the upstream survey extents the slope is approximately 2.1 percent. Within the survey limits, the upstream ranges from 2.1 to 3.5 percent with a steep slope into the culvert. At Station 18+90 on the long channel profile a natural wood weir creates a 2-foot drop.

Downstream, the channel meanders between vegetated floodplains with some eroded banks around sharp curves. Within the survey extents, the stream is at a 1.5 to 1.9 percent slope. At Station 13+25 there is another natural wood weir with a 1-foot drop. Skookum Creek comes in on the right bank at Station 11+50, and a log jam at Station 11+25 creates a 2-foot elevation drop. Past the survey extents the stream grade remains fairly consistent at a slope of approximately 1.3 percent.

During the site visit no excessive sediment deposits were observed. Minimal risk of aggradation and degradation is expected within this reach; there is no discontinuity within the long channel profile and no measurable aggradation or degradation was observed. Aggradation and degradation are expected to be less than 1 foot for both.

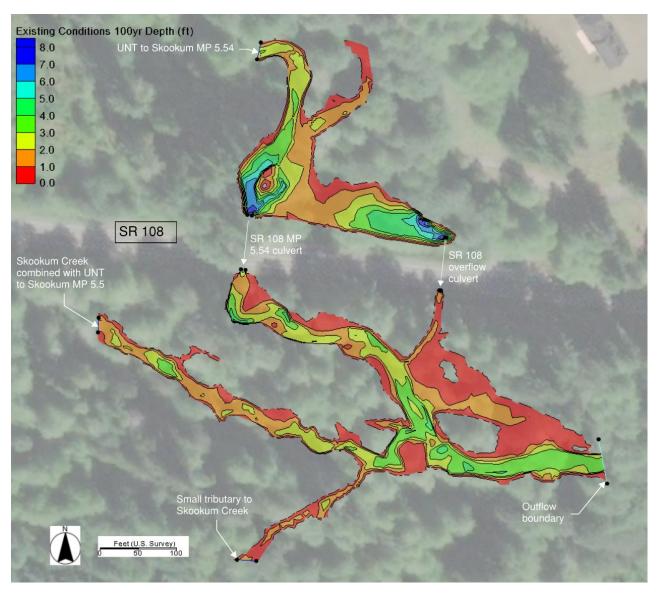
Figure 44: Hydraulic model boundary conditions

Hydrologic calculations were performed for three separate basins: (1) SR 108 MP 5.54 UNT basin, (2) the Skookum Creek mainstem above the UNT, and (3) an additional UNT on the right bank of the Skookum Creek mainstem, approximately 80 feet upstream of the confluence with the UNT and Skookum Creek. See Figure 44 below for locations of the boundary conditions; note there are three inflow locations.

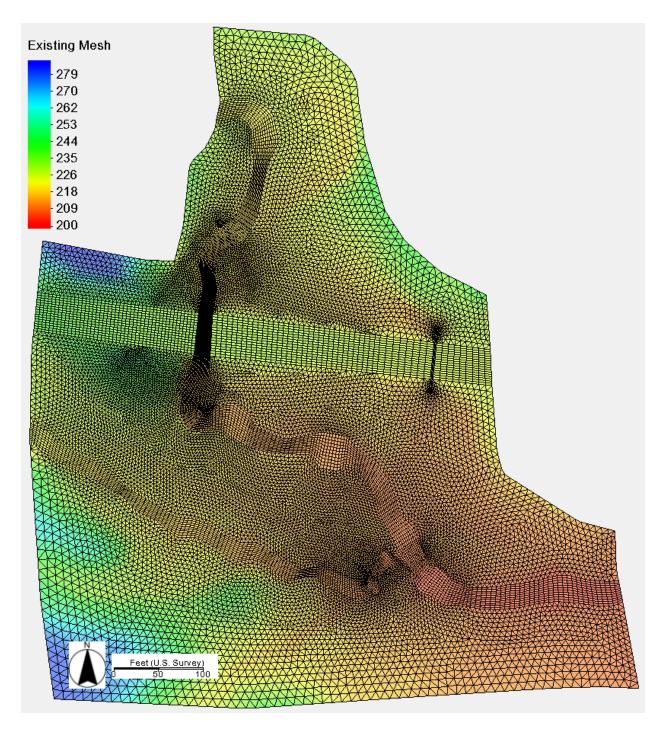
Figure 45: Existing-conditions computational mesh with underlying terrain

The upstream and downstream hydraulic model extents are consistent with the survey data extents. LiDAR was used to supplement additional floodplain areas. The detailed survey data starts approximately 275 feet upstream of the existing culvert inlet and end 640 feet downstream of the existing culvert outlet, measured along the channel centerline. The computational mesh elements are a combination of patched (quadrilateral) and paved (triangular) elements, with finer resolution in the channel and larger elements in the floodplain. The existing mesh covers a total area of 328,836 SF, with 6,767 quadrilateral and 26,666 triangular elements (see Figure 45). The proposed mesh covers a total area of 327,542 SF. This is slightly different from existing because of holes in the mesh used to simulate a structure. The proposed mesh has 6,448 quadrilateral and 26,916 triangular elements (see Figure 46).

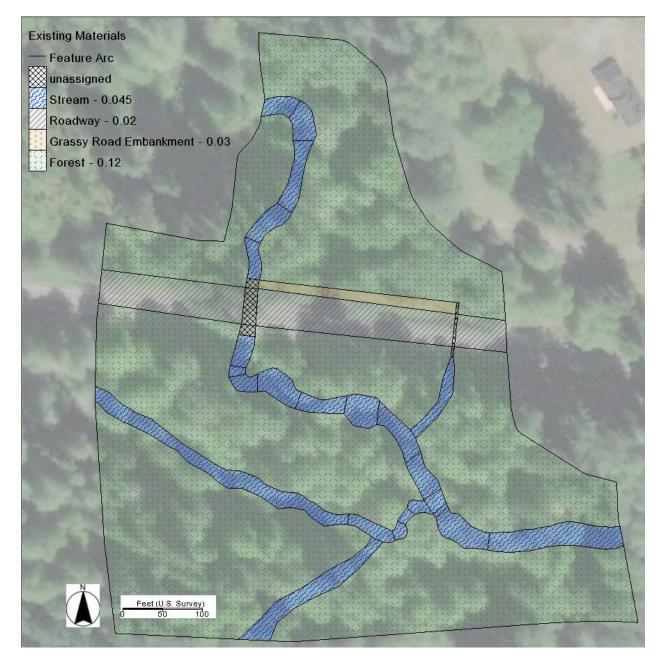
Figure 47: Spatial distribution of roughness values in existing-conditions SRH-2D model

Land Cover Type	Manning's n
Channel	0.045
Floodplains	0.12
Roadway	0.02
Grassy road embankment	0.03

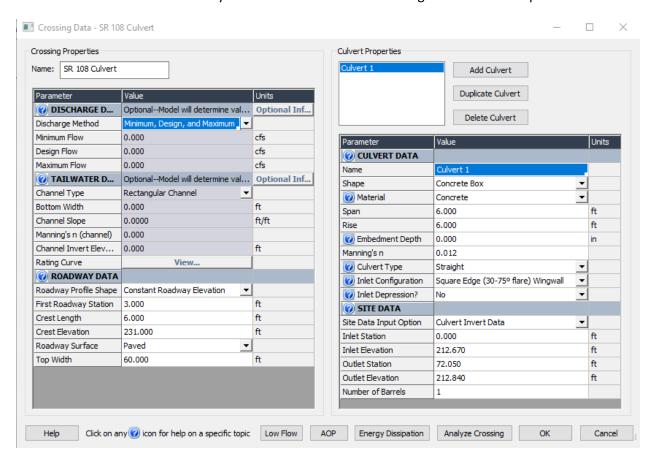
Figure 49: SR 108 HY-8 culvert parameters

An HY-8 internal boundary condition was specified in the existing-conditions model to represent the existing concrete box culvert crossing. The existing crossing was modeled as a 6-foot-diameter box culvert within HY-8. A Manning's roughness of 0.012 was assigned to the culvert, which was assumed to be unobstructed and free from any stream material within it. See Figure 49 for HY-8 inputs.

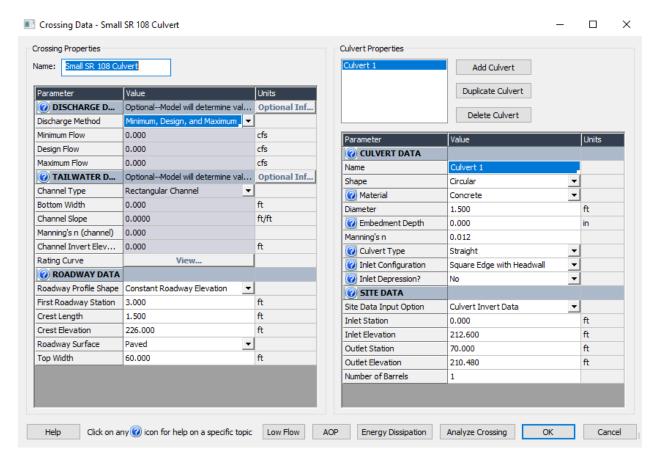
Figure 50: Overflow HY-8 culvert parameters

A second HY-8 internal boundary condition was incorporated in both the existing- and proposed-conditions models to represent the circular concrete overflow culvert to the east of the main SR 108 crossing. This existing culvert was modeled as a 1.5-foot-diameter circular pipe within HY-8. A Manning's roughness of 0.012 was assigned to the culvert, which was assumed to be unobstructed and free from any stream material within the barrel. See Figure 50 for HY-8 inputs.

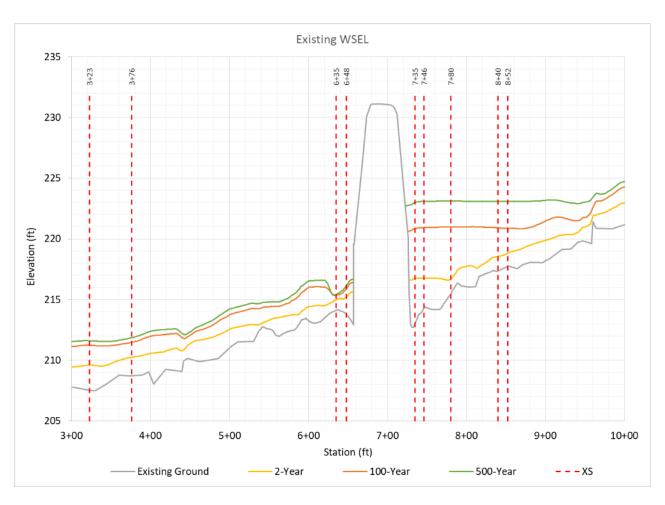
Figure 54: Existing-conditions water surface profiles

The existing-conditions hydraulic profile is provided in Figure 54. The profile shows that water backwaters approximately 150 feet upstream of the existing culvert during the 100-year flood event. A cross section upstream of the culvert is provided in Figure 55. All other cross-section figures are provided in Appendix B.

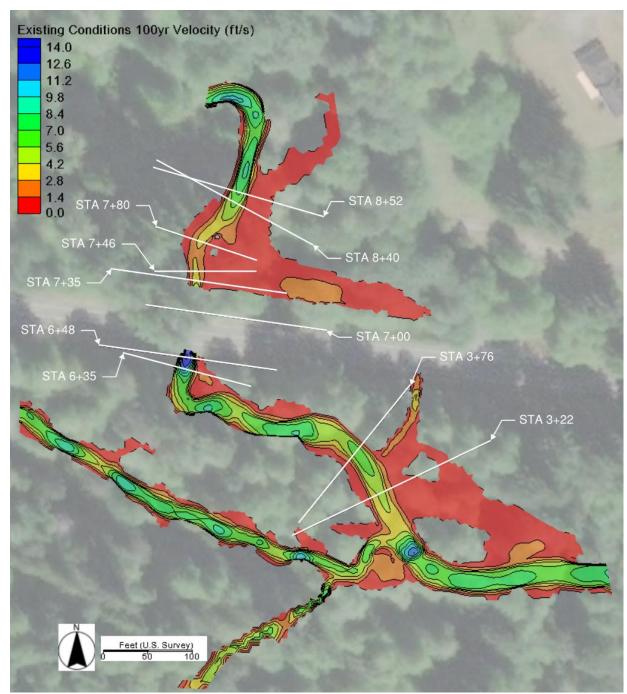
Figure 56: Existing-conditions 100-year velocity map with cross-section locations

Velocity magnitudes are illustrated at the 100-year event in Figure 56 and summarized for the main channel and floodplains in Table 7.

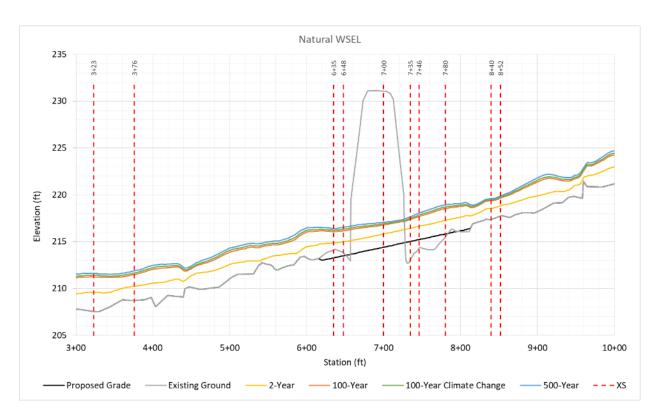
Figure 57: Natural-conditions water surface profiles

The natural-conditions hydraulic profile, provided in Figure 57, shows that water no longer backwaters upstream of the roadway during all flood events. A cross section located within the removed roadway is provided in Figure 58. All other cross-section figures are provided in Appendix B.

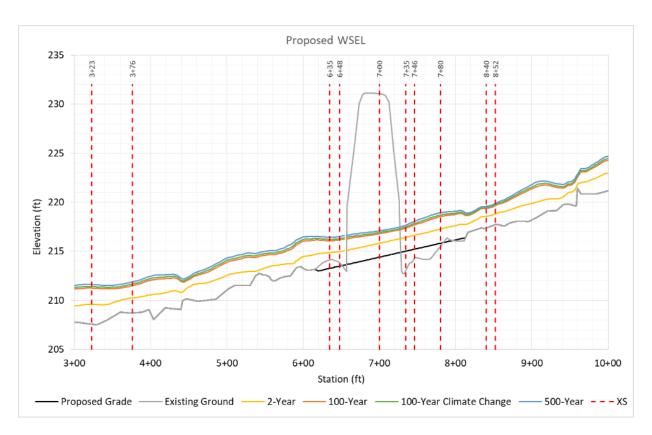
Figure 61: Proposed-conditions water surface profiles

The proposed-conditions hydraulic profile is provided in Figure 61. The profile shows that water no longer backwaters upstream of the roadway during all flood events. A cross section located upstream of

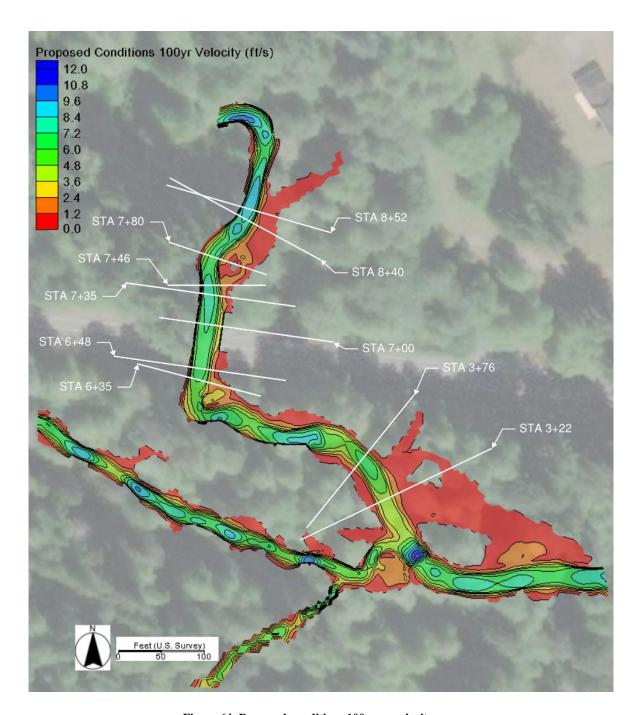
Figure 64: Proposed-conditions 100-year velocity map

The velocity within the structure is an average of 7.5 ft/s at the center of the channel for the 100-year event. At the upstream reference reach the velocity ranges from 8.7 to 9.4 ft/s. These velocities are higher than what was shown in existing, most likely due to backwater from the undersized culvert. Immediately downstream of the culvert outlet, velocities decreased significantly from 9.2 to 11.4 ft/s at the existing conditions to 5.6 to 6.1 ft/s for the proposed conditions. At the downstream reference reach the velocity ranges from 5.5 to 6.4 ft/s. High velocities within the proposed conditions (10 to 12 ft/s for the 100-year event) are at the same areas as was seen in the existing conditions, downstream of obstructions.

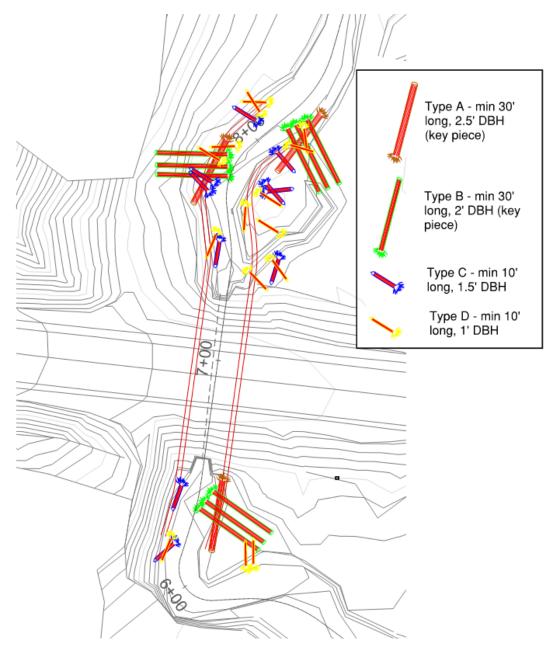
Figure 66: Conceptual layout of habitat complexity

It is not expected that fish stranding during summer flows will be a risk as the floodplain slopes consistently toward the main channel and does not promote standing water to form within the floodplain of the proposed project extents.

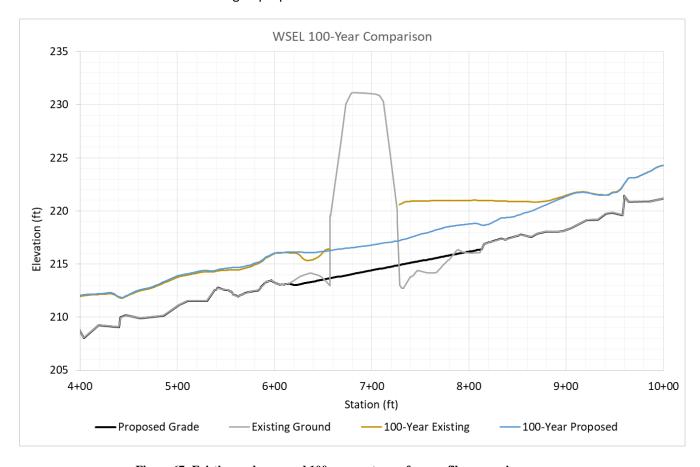
Figure 67: Existing and proposed 100-year water surface profile comparison

Immediately downstream of the culvert, channel regrading for proposed conditions causes a rise as much as 0.7 foot in water surface elevation near Station 6+35. The local water surface rise is a result of regrading the channel and removing the debris and sediment that have filled the stream downstream of the existing culvert outlet. Past the outlet, the water surface elevation change varies between no change and a 0.21-foot rise from the existing to proposed conditions.

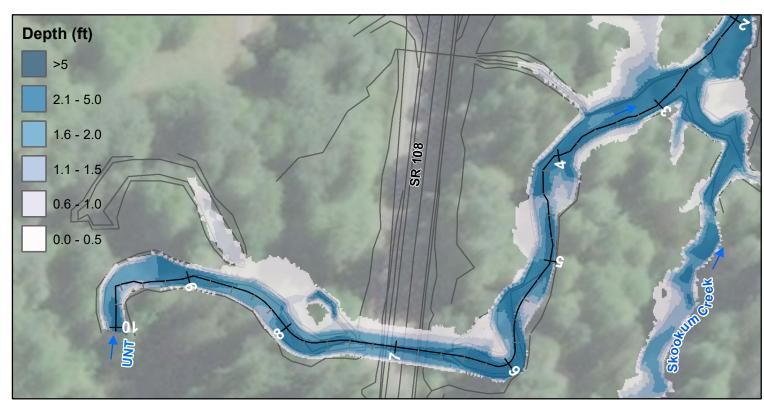
EXISTING CONDITIONS 25-YEAR

WATER SURFACE ELEVATION

DEPTH

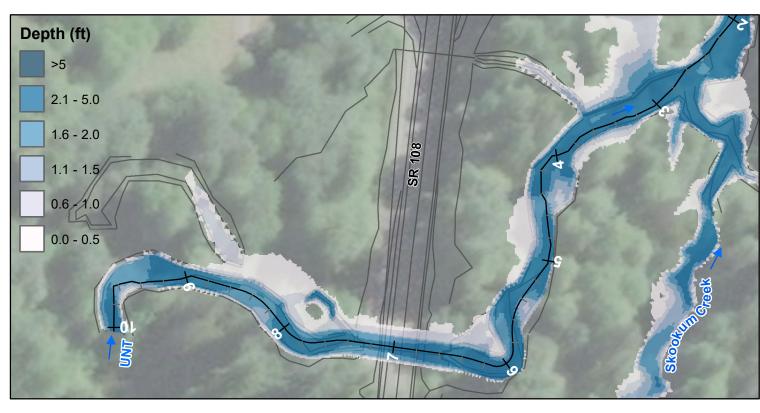
EXISTING CONDITIONS 50-YEAR

WATER SURFACE ELEVATION

DEPTH
